## Category: BlueHeat

Document Number: 5001059A

Description: BlueHeat - Installation of time delay relay to prevent MIL from illuminating.

Kit Part No.: 5001058A

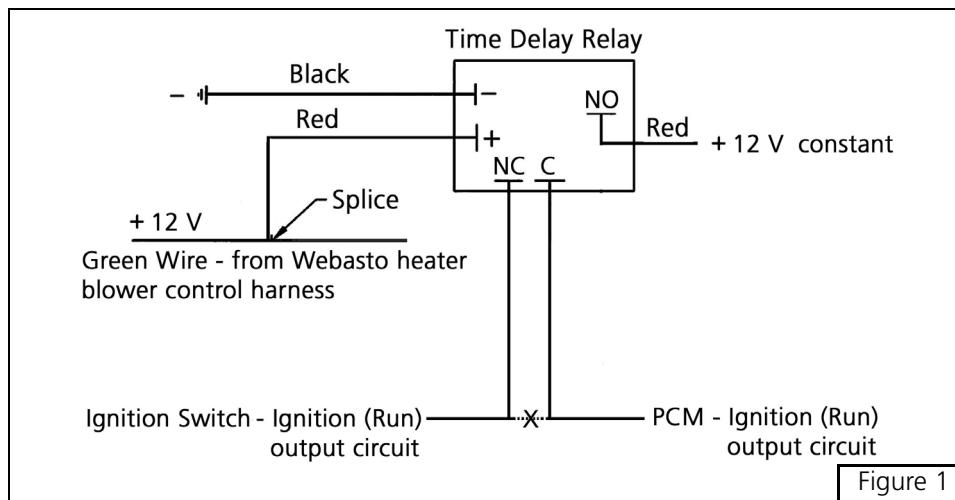
Operation of the BlueHeat coolant heater (increasing coolant temperature) may cause DTC P0116 to set if the conditions for running the diagnostic are met. This occurrence can be eliminated by providing the ECU with an ignition ON signal prior to heater operation. Webasto recommends the use of a time delay relay to provide this ignition ON signal whenever the heater is activated.

Using the manufacturer's service instructions, locate the fused ignition output (RUN) circuit at the ignition switch, and connect the time delay relay as shown in Figure 1.
